## TEST REPORT

No. : XMIN1909006675ML

Sample Name : TILT ARM FRONT&REAR LEG

Material and Mark : AL6005-T5

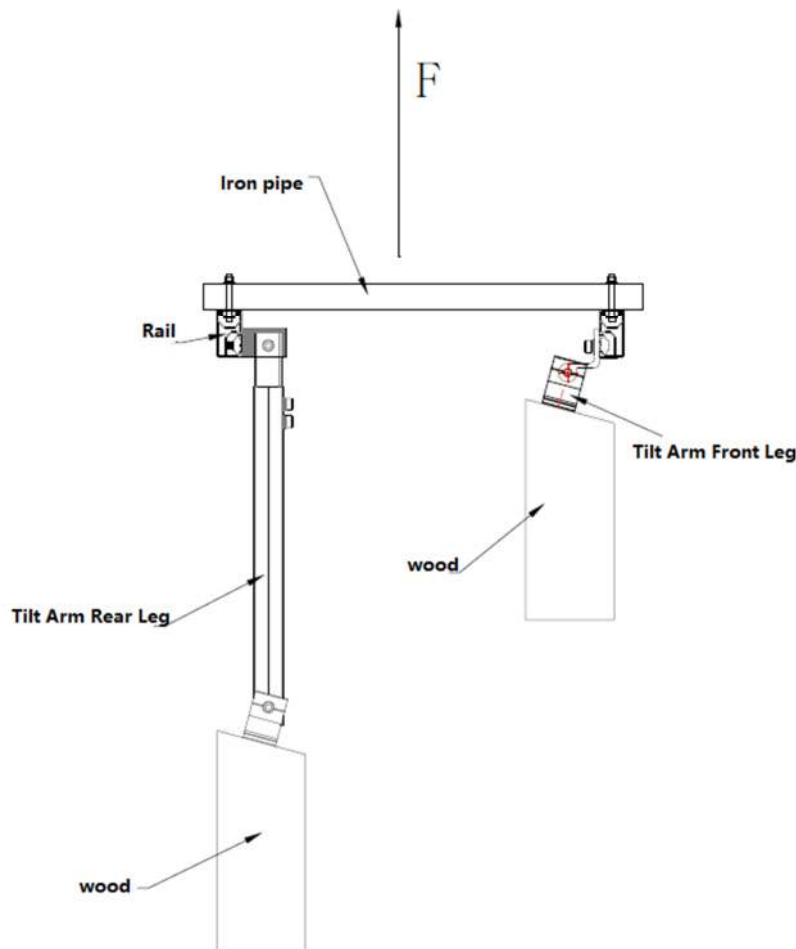
Test sketch:

Test method: accord to the client's requirement, as the following:

Step 1: Fix the wood on the test machine;

Step 2: Fasten the tilt arm front&rear leg on the wood;

Step 3: Cut a rail into two, and install it on the tilt arm front&rear leg respectively.

Step 4: Install an iron pipe on the rail.

Step 5: Apply upward load to the center of the iron pipe till the assembly destruction.

Step 6: Record the maximum force.

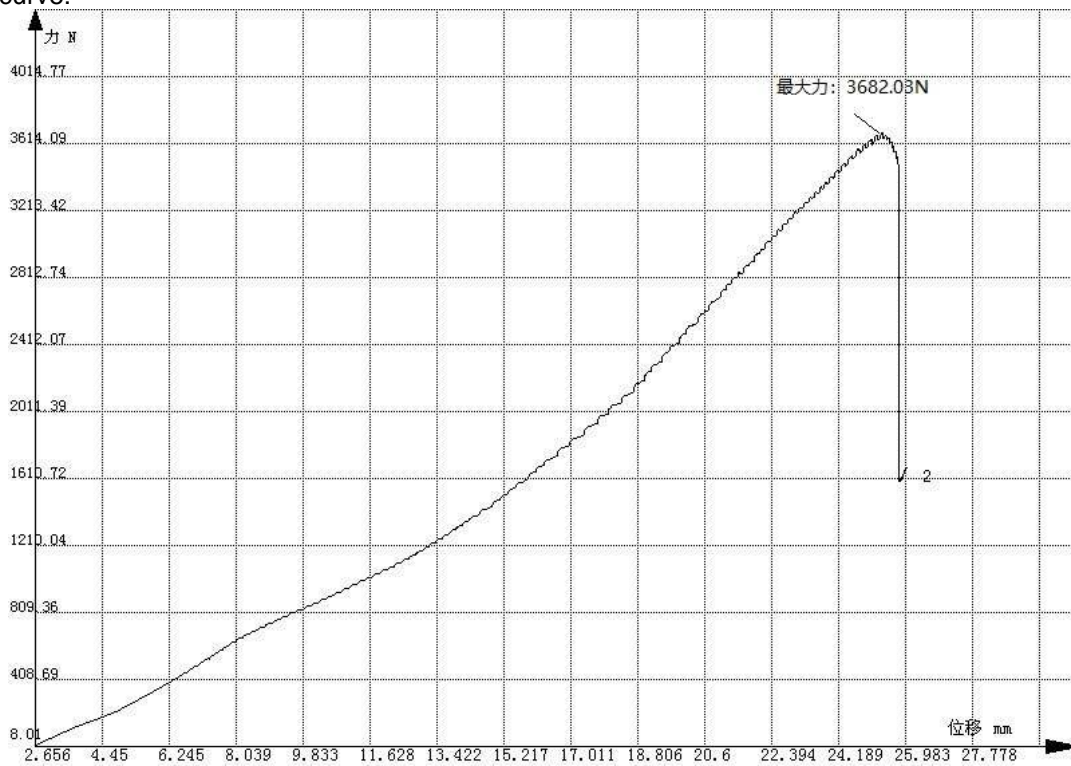
Force-displacement curve

Test item	Test result
Pull test	the maximum force is 3682 N

Note: Tilt arm rear leg: 184mm

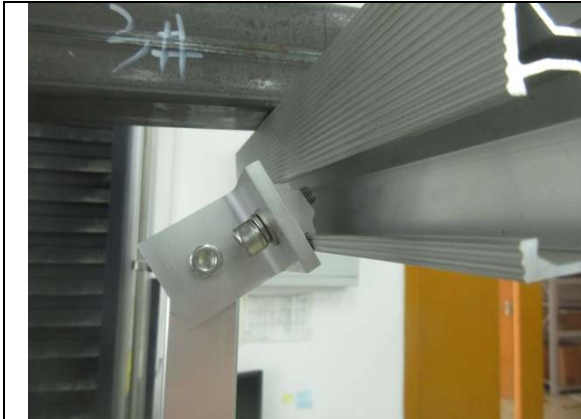
Photo 5: part view after destruction

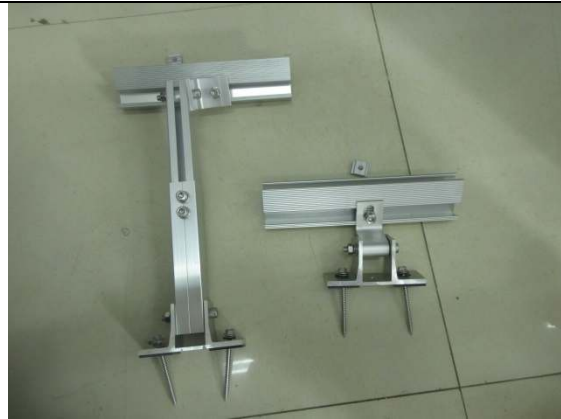
Photo 6: the sample after test
