## TEST REPORT

No. : XMIN2003001197ML

Sample Name : TILT ARM FRONT&REAR LEG

Material and Mark : AL6005-T5

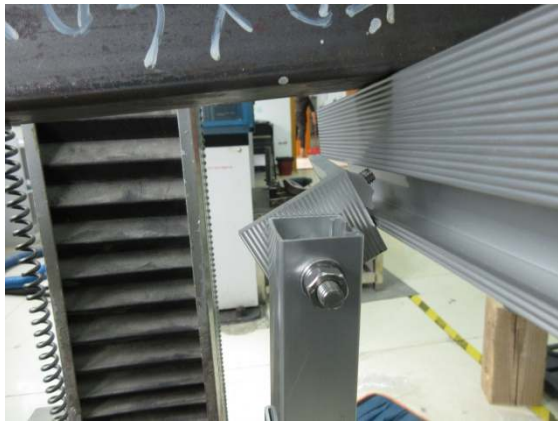
Photo 5: part view after destruction

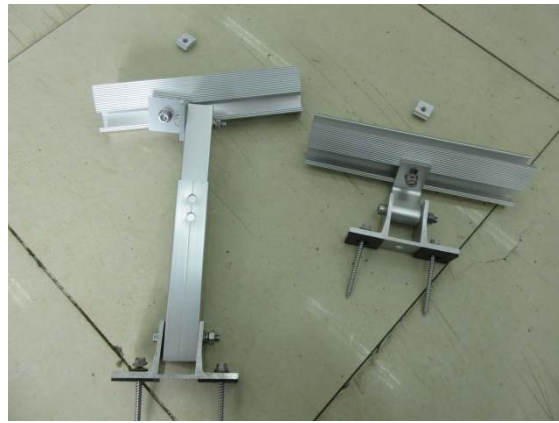
Photo 6: the sample after test
