TEST REPORT

No. : XMIN1912009101ML

Sample Name : TILT ARM FRONT&REAR LEG
Material and Mark : AL6005-T5

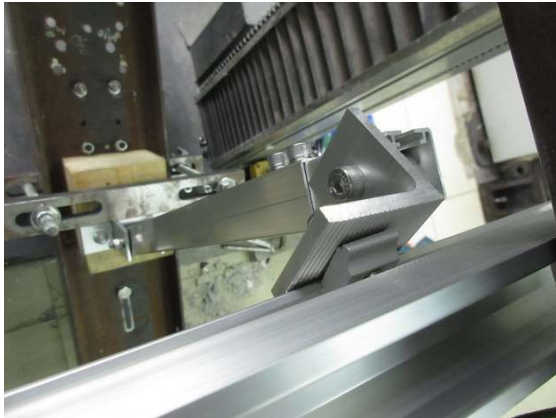
Photo 5: part view after destruction

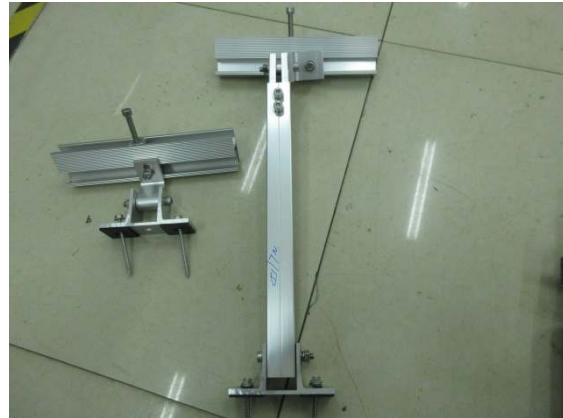
Photo 6: the sample after test
