TEST REPORT

No. : XMIN1906003775ML

Sample Name : 6.3x80 WOOD SCREW

Pull test:

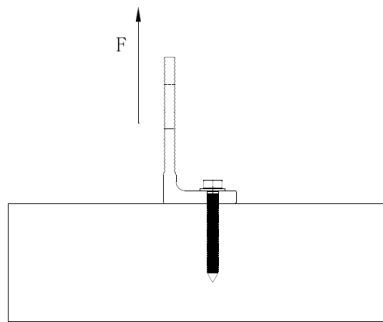
Test sketch:

Test method: according to the client's requirements, fix the sample on the test machine. Apply the pull force as a rate of 5mm/min till destruction. Determine the maximum force.

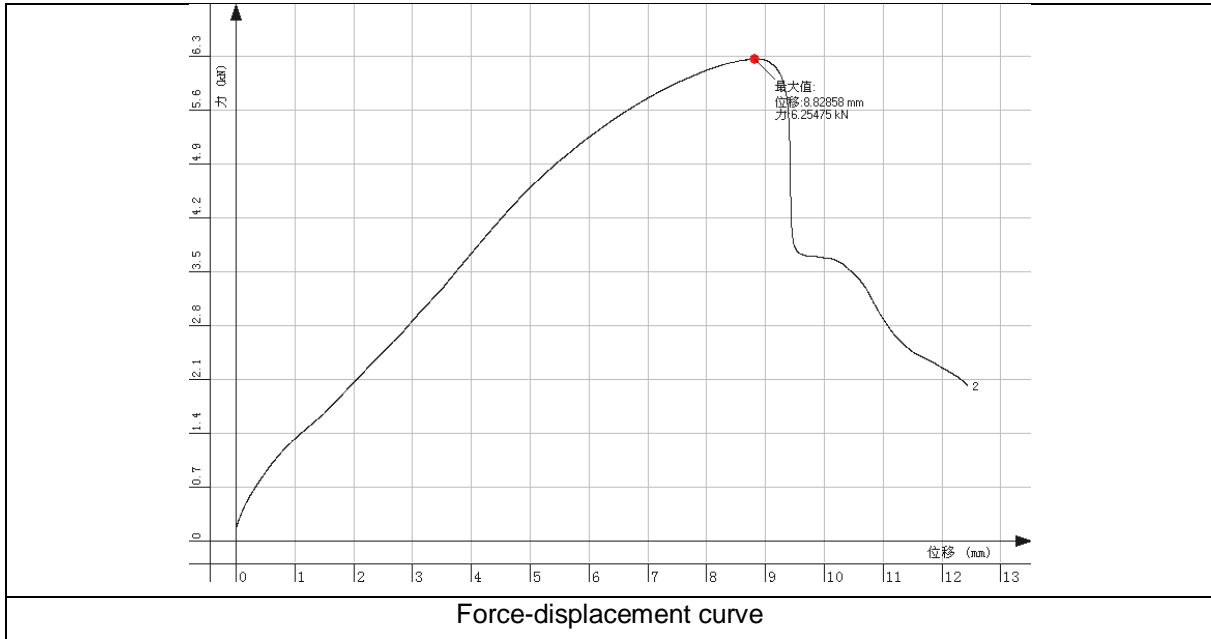
Test curve:

Test item	Maximum force (kN)
Result	6.25

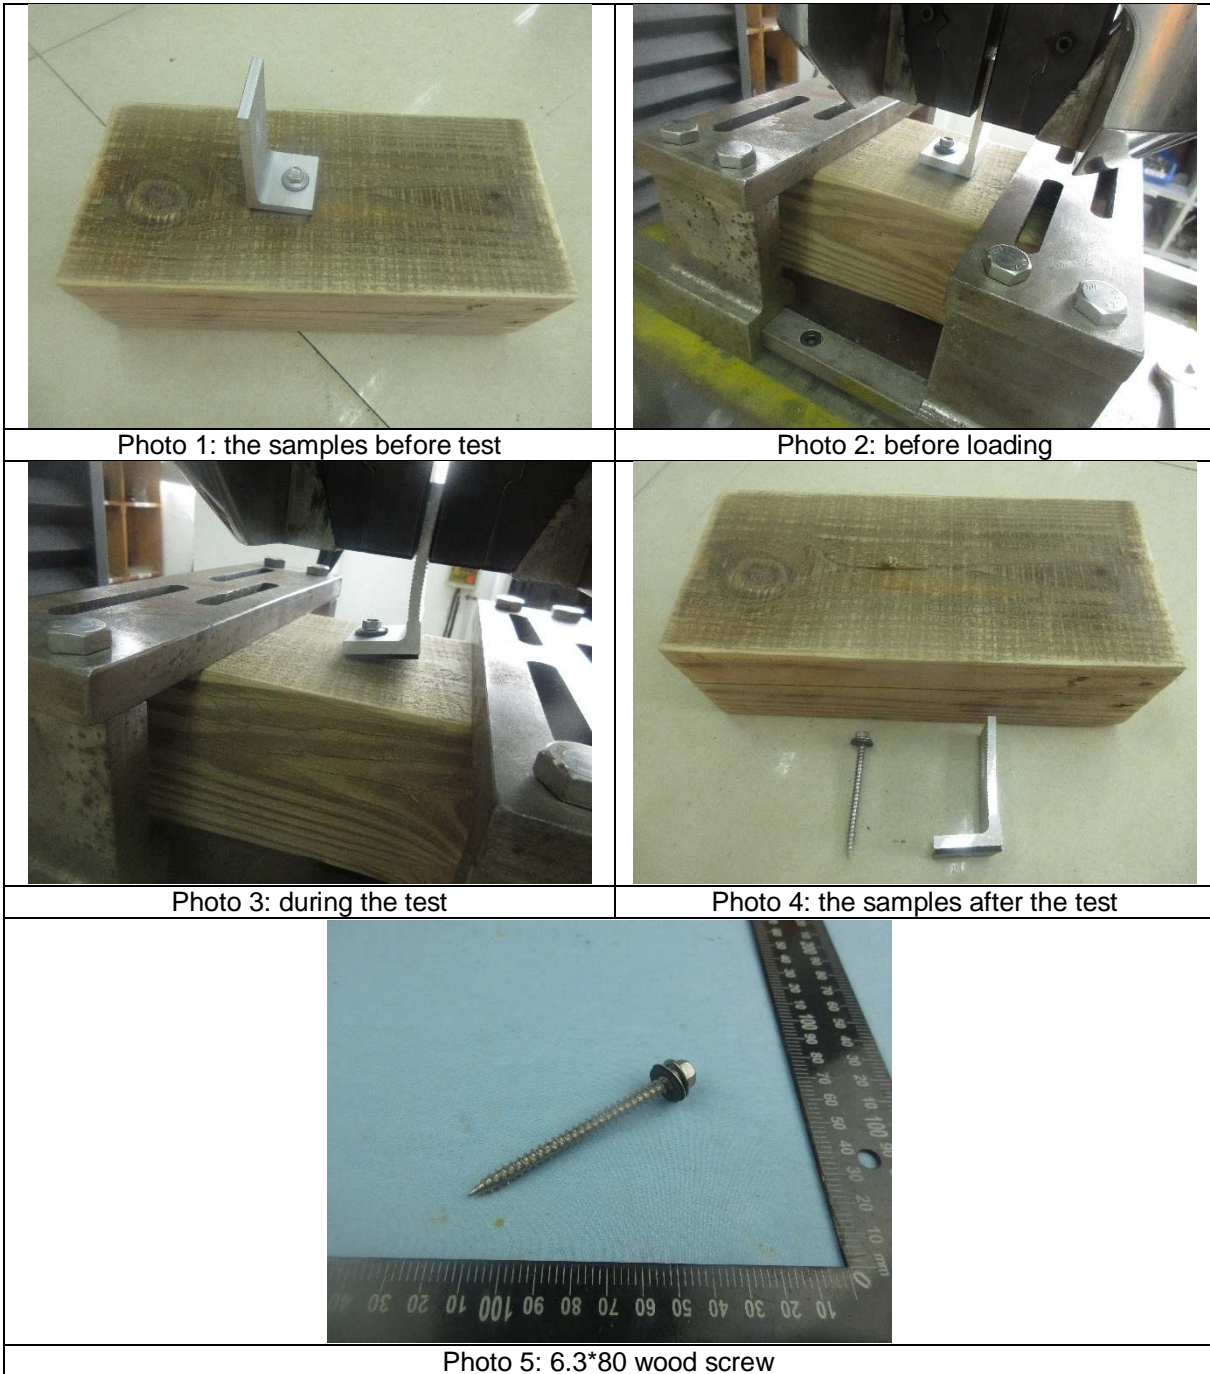
Test Photo:

Photo 1: the samples before test

Photo 2: before loading

Photo 3: during the test

Photo 4: the samples after the test

Photo 5: 6.3*80 wood screw
