TEST REPORT

No. : XMIN2004002494ML

Sample Name : TILT ARM FRONT&REAR LEG

Material and Mark : AL6005-T5

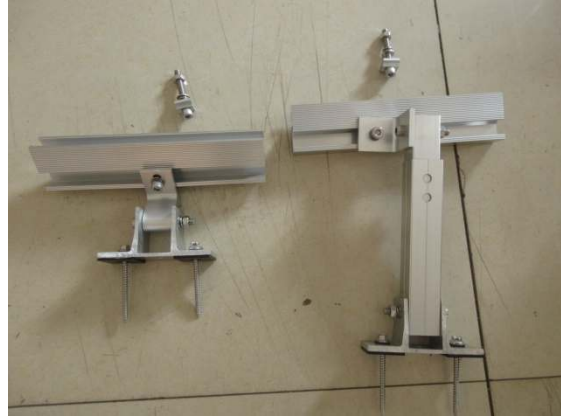
Photo 6: the sample after test
