TEST REPORT

No. : XMIN1708005412ML

Sample Name : PRESS BLOCK (GM-EC-40)

Material and Mark : Al6005-T5

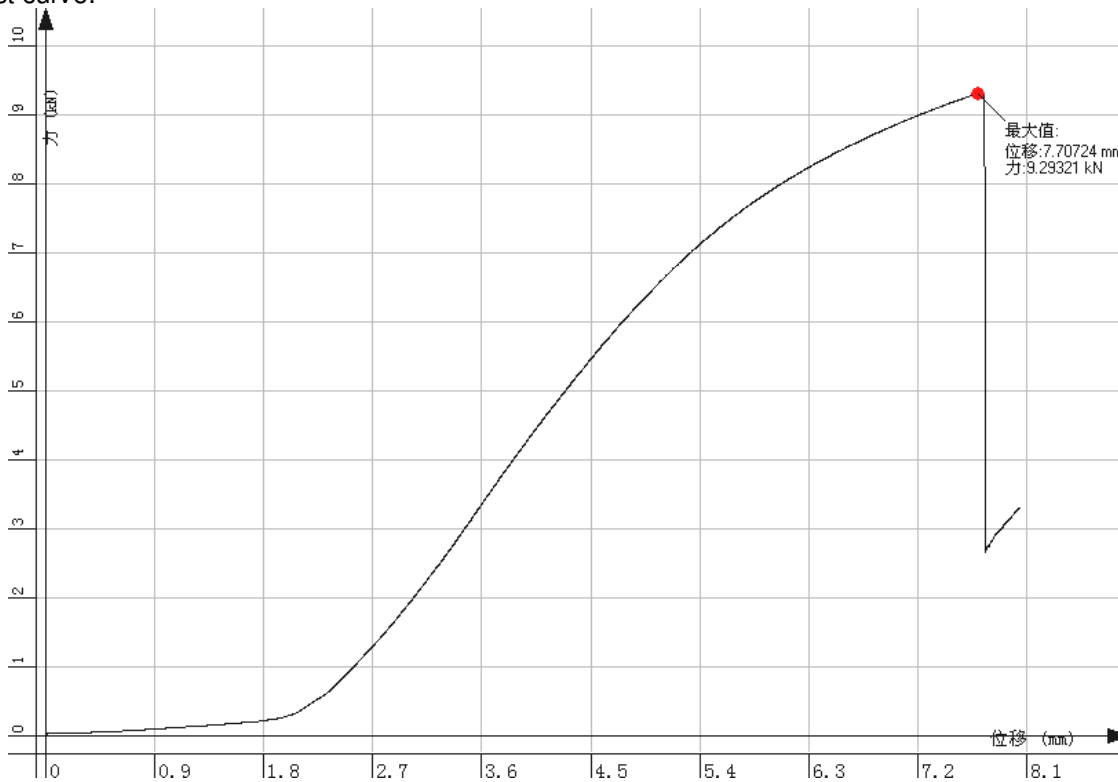
Test method: according to the client's requirements, fixed the sample on the test machine. Apply the pull force as a speed of 5mm/min till damage. Determine the maximum force.

Test item	Maximum force
Pull test	9293N

Force-displacement curve

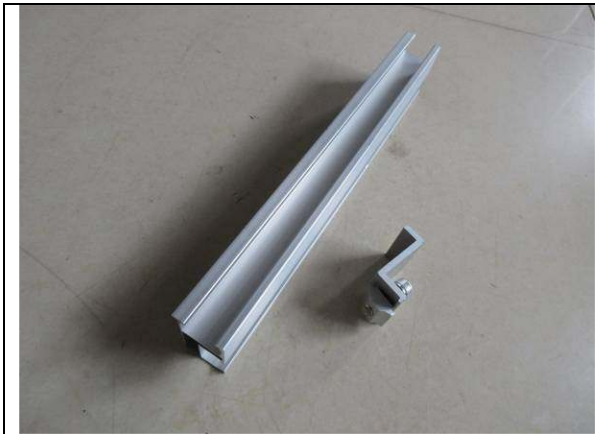
Photo 1: the sample before test

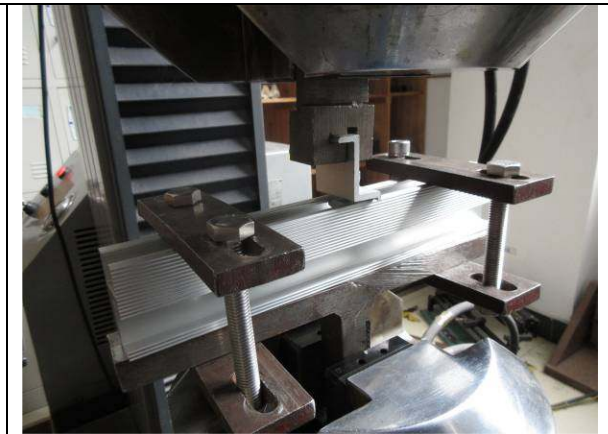
Photo 2: during the test

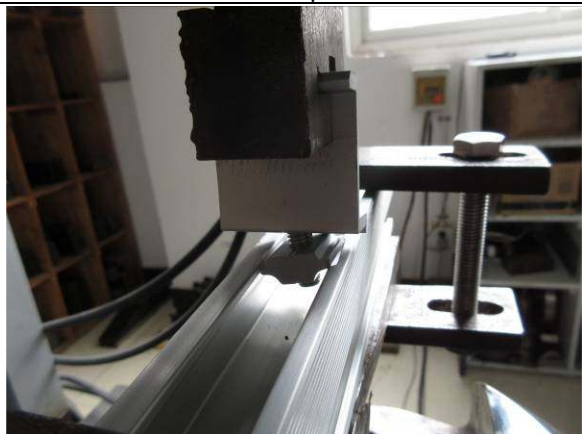
Photo 3: after the test

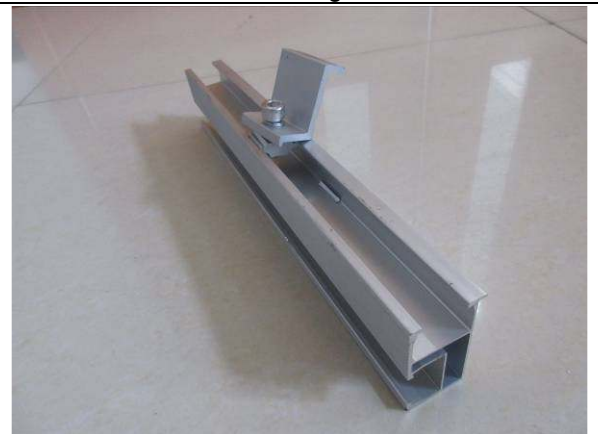
Photo 4: The sample after test
