## TEST REPORT

No. : XMIN1708005413ML-01

Sample Name : PRESS BLOCK (GM-MC-40)

Material and Mark : Al6005-T5

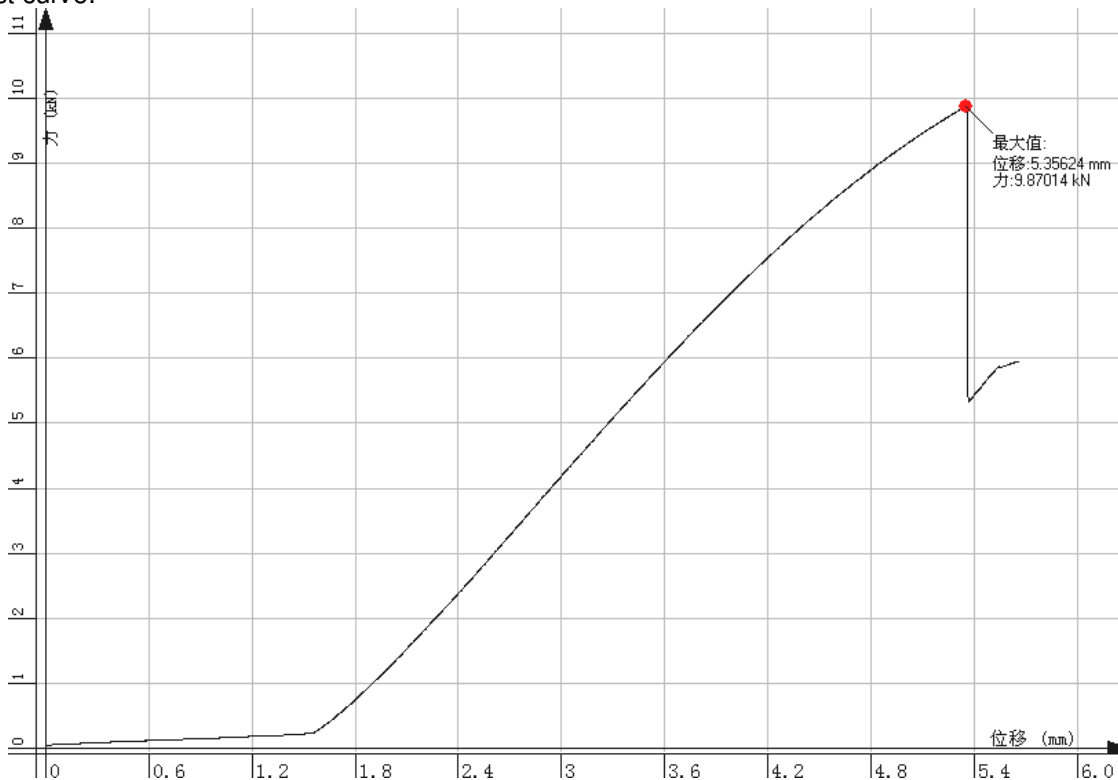
Test curve:

Pull test:

Test method: according to the client's requirements, fixed the sample on the test machine. Apply the pull force as a speed of 5mm/min till damage. Determine the maximum force.

Test item	Maximum force
Pull test	9870 N

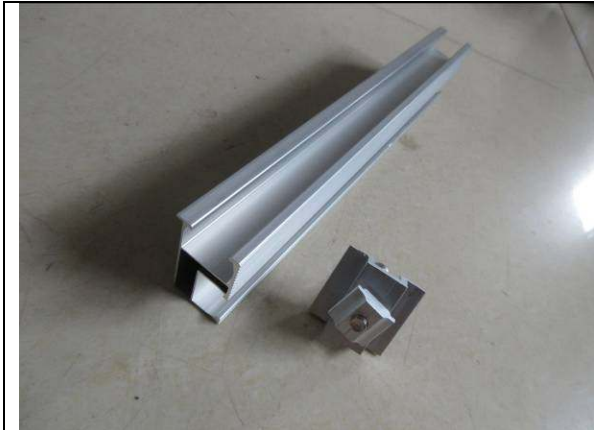
Photo 1: the sample before test

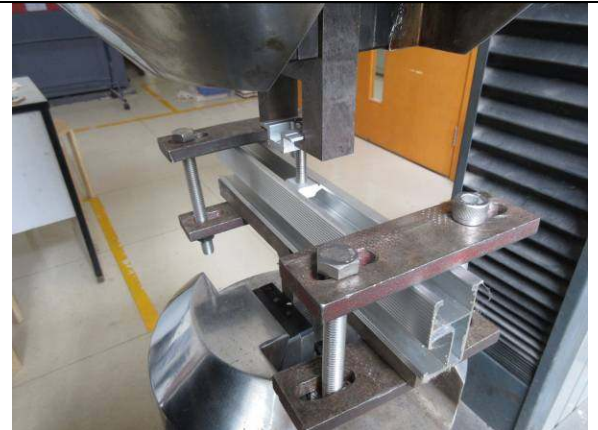
Photo 2: during the test

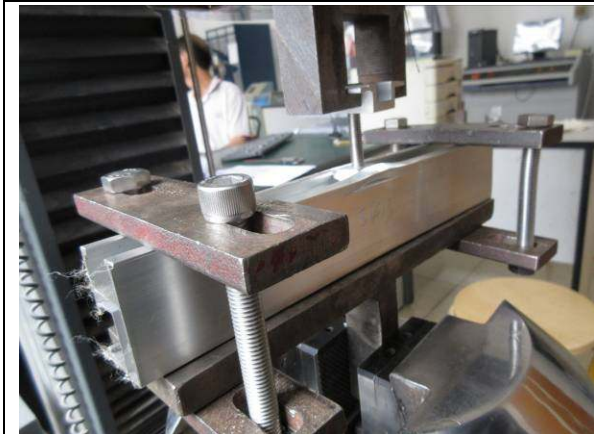
Photo 3: after the test

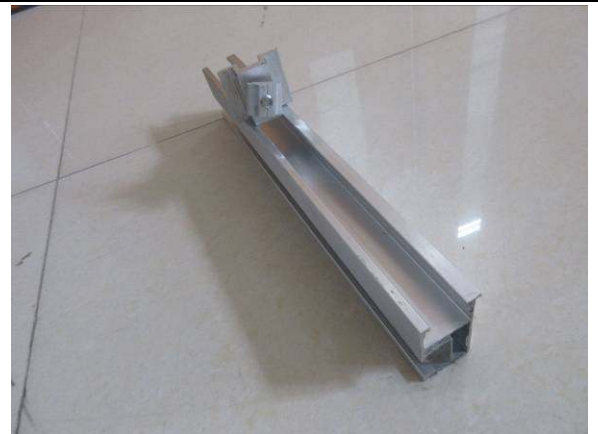
Photo 4: The sample after test
