## TEST REPORT

No. : XMIN1707004568ML

Sample Name : CLAMP (GM-MRH-07)

Material and Mark : AL6005-T5

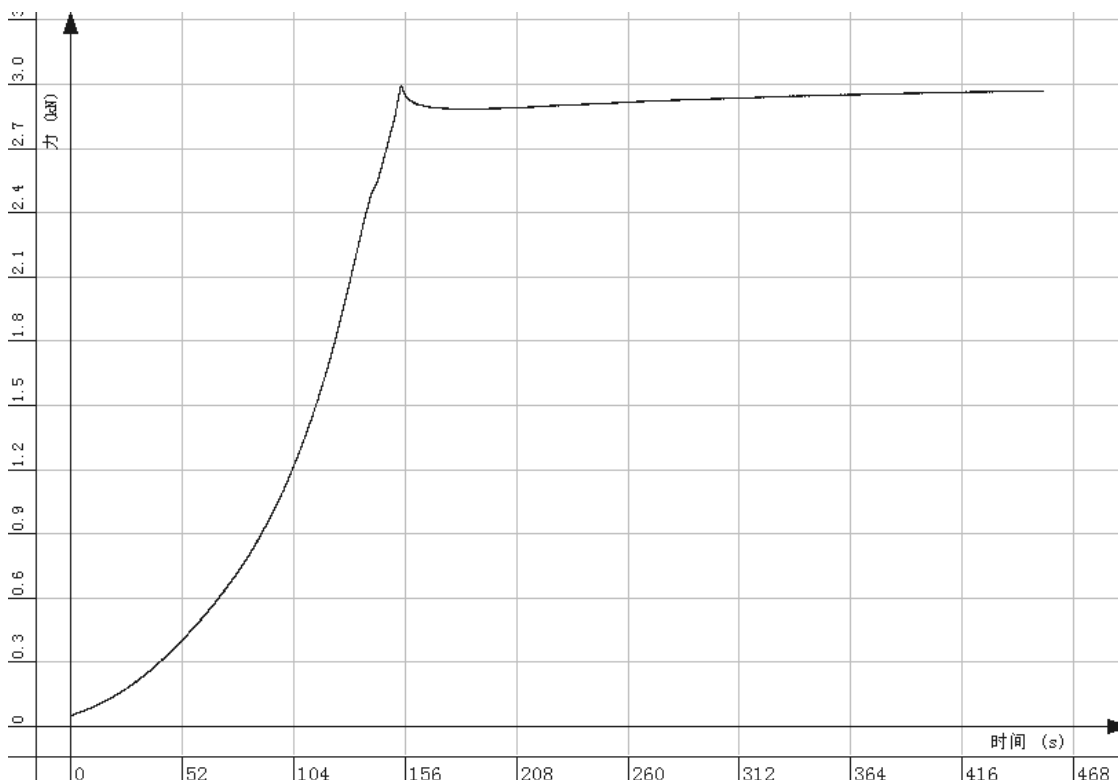
Force-Time curve

Test method: according to the client's requirements, fixed the sample on the test machine. Apply the pull force as a speed of 12mm/min till 3kN, if the clamp without pulled out, then hold the force for 5 min. Observe whether the clamp pulled out after the test.

Test item	Load to 3kN	Hold 3kN force for 5min
Pull test	Without pulled out	Without pulled out

Test curve:
