# TEST REPORT

No. : XMIN1509005443ML

Sample Name : METAL ROOF CLIPS  
Date of Receipt : Sep 02, 2015  
Testing Start Date : Sep 06, 2015  
Testing End Date : Sep 11, 2015  
Test result(s) : For further details, please refer to the following page(s)

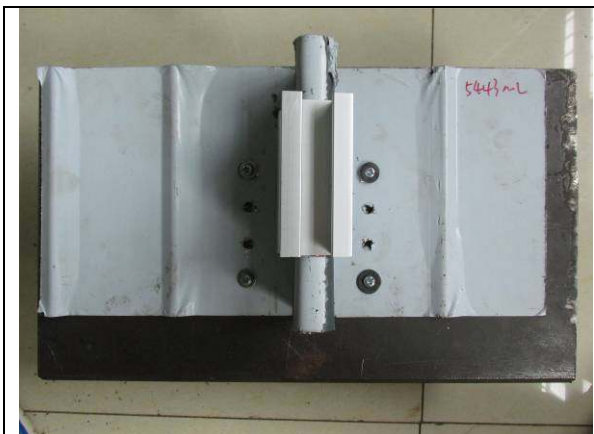
Photo 1: Sample

Fix the sample as photo 1 & photo 2. Load force with 10mm/min. Determine the max force

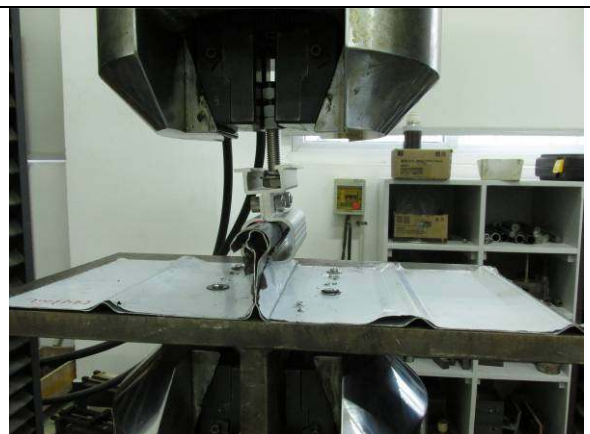
Photo 2: Before the test

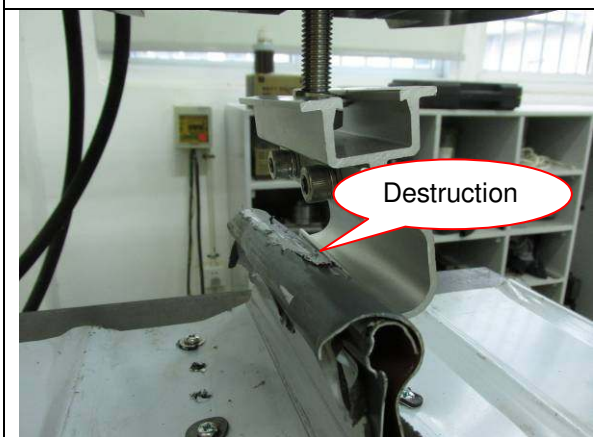
Photo 3: After the test

| Test item | Test result |
|---|---|
| Pull test | When the sample destruction (see photo 3) the maximum force (F) 2.822KN |

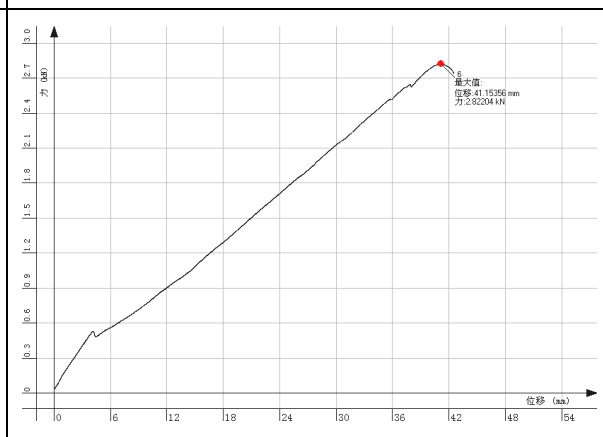
Photo 4: Force-displacement curve
