TEST REPORT

No. : XMIN1811008178ML

Sample Name : L FEET
Material and Mark : AL6005-T5

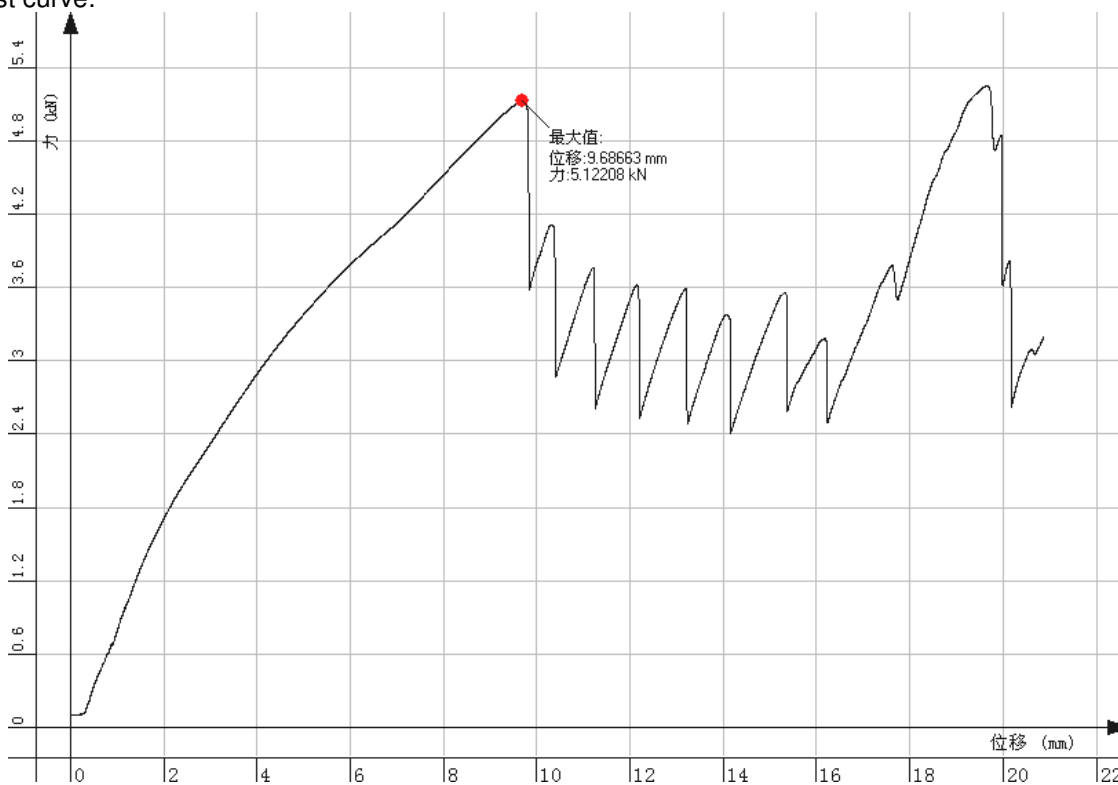
Test curve:

Test method: according to the client's requirements, Lock the sample on the square tube with self-tapping screws and fix the sample on the test machine. Apply the pull force as a rate of 5mm/min till destruction. Determine the maximum force.

Test item	Result
Pull Test	Maximum force:5122N. The square tube deforms and the self-tapping screw was pulled out

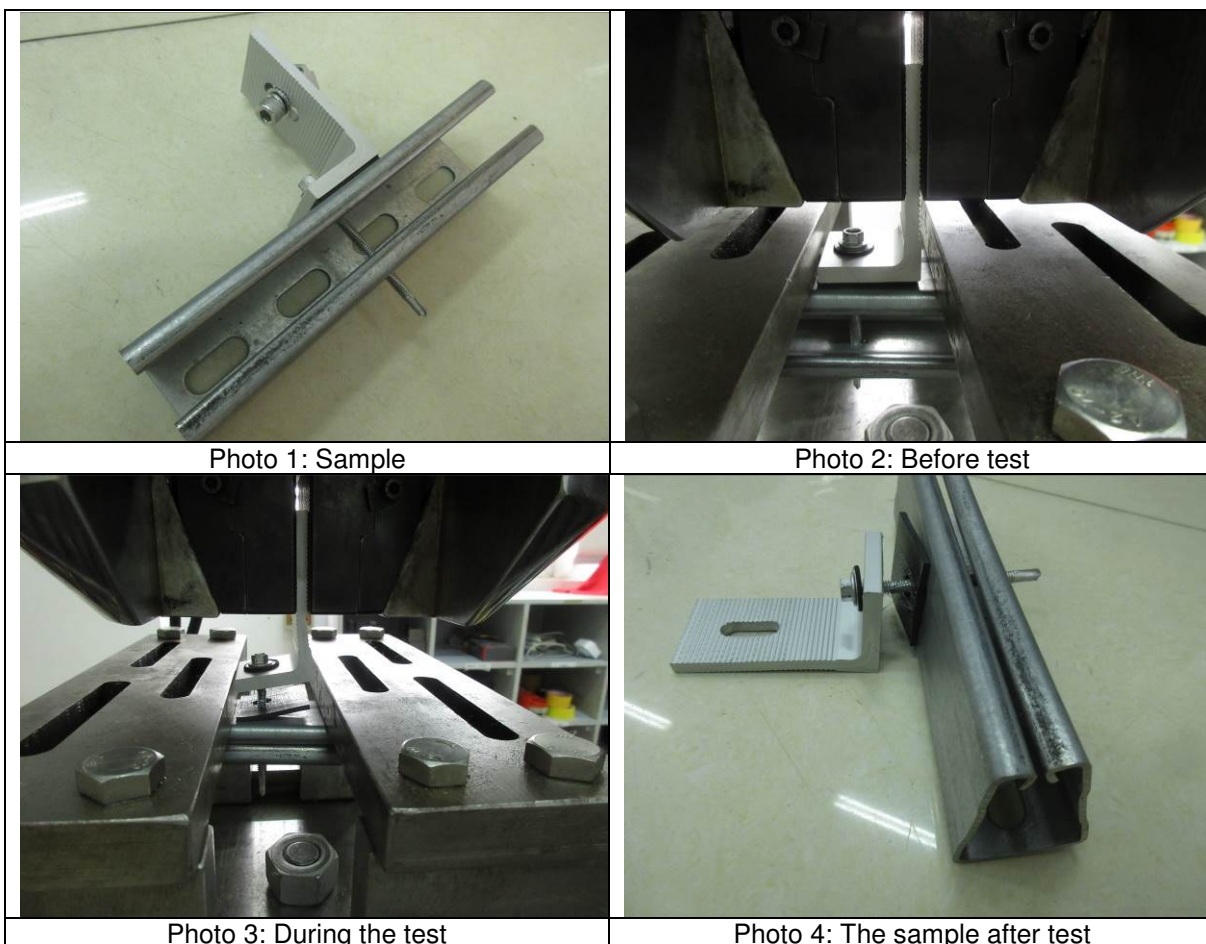
Test Photo:

Photo 1: Sample

Photo 2: Before test

Photo 3: During the test

Photo 4: The sample after test
