TEST REPORT

No. : XMIN1708005414ML

Sample Name : CLAMP(GM-MRH-LDS-03)

Material and Mark : Al6005-T5

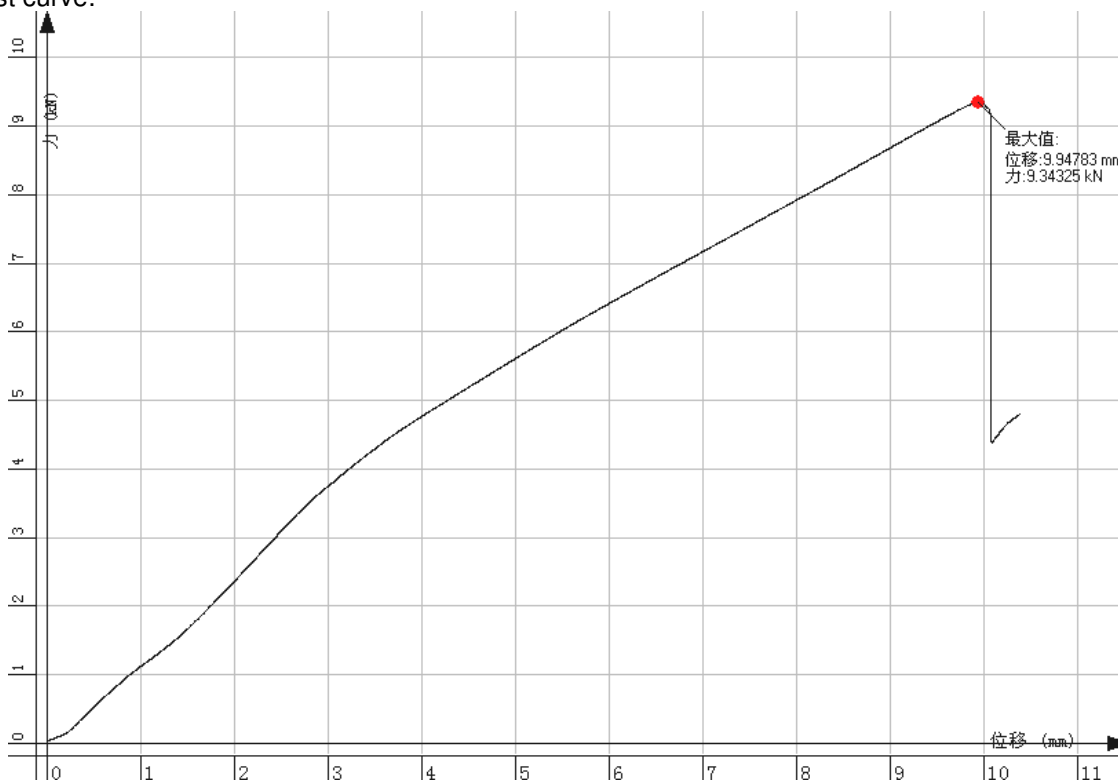
Test curve:

Force-displacement curve

Test method: according to the client's requirements, fixed the sample on the test machine. Apply the pull force as a speed of 5mm/min till damage. Determine the maximum force.

Test item	Maximum force
Pull test	9343N

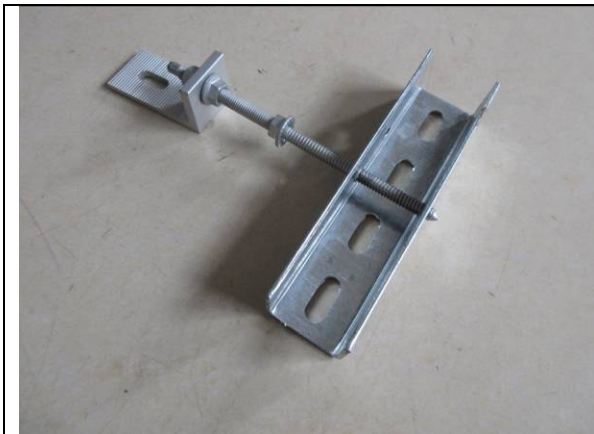
Photo 1: the sample before test

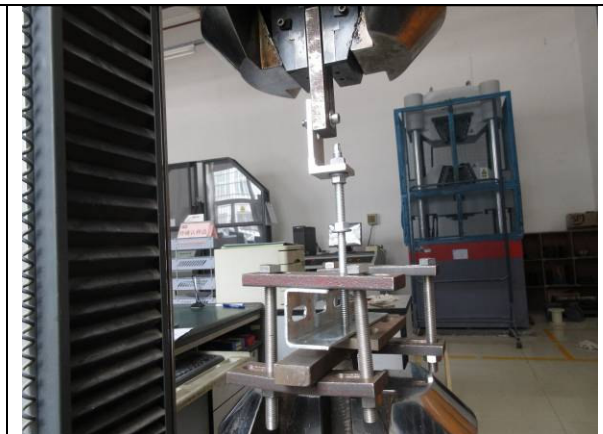
Photo 2: during the test

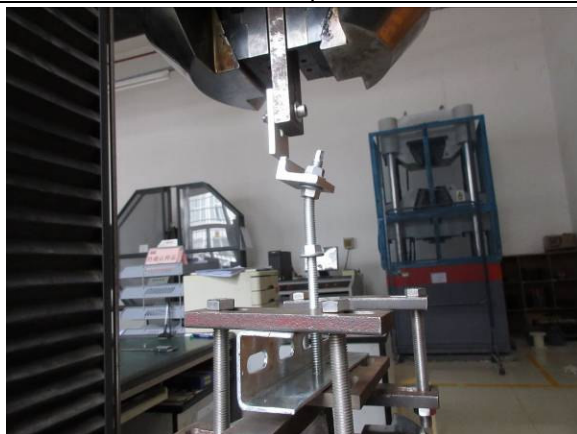
Photo 3: after the test

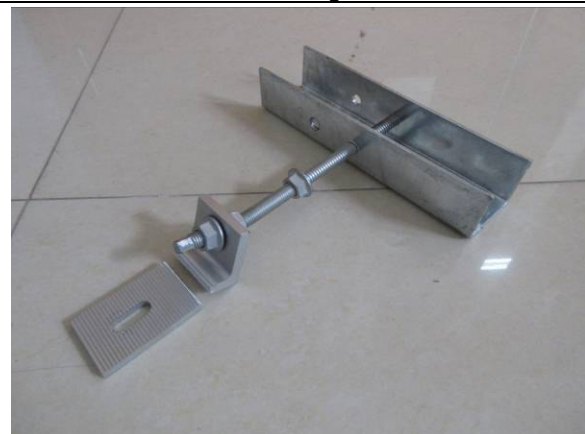
Photo 4: The sample after test
