TEST REPORT

No. : XMIN1801000548ML

Sample Name : GM-R11
Material and Mark : AL6005-T5

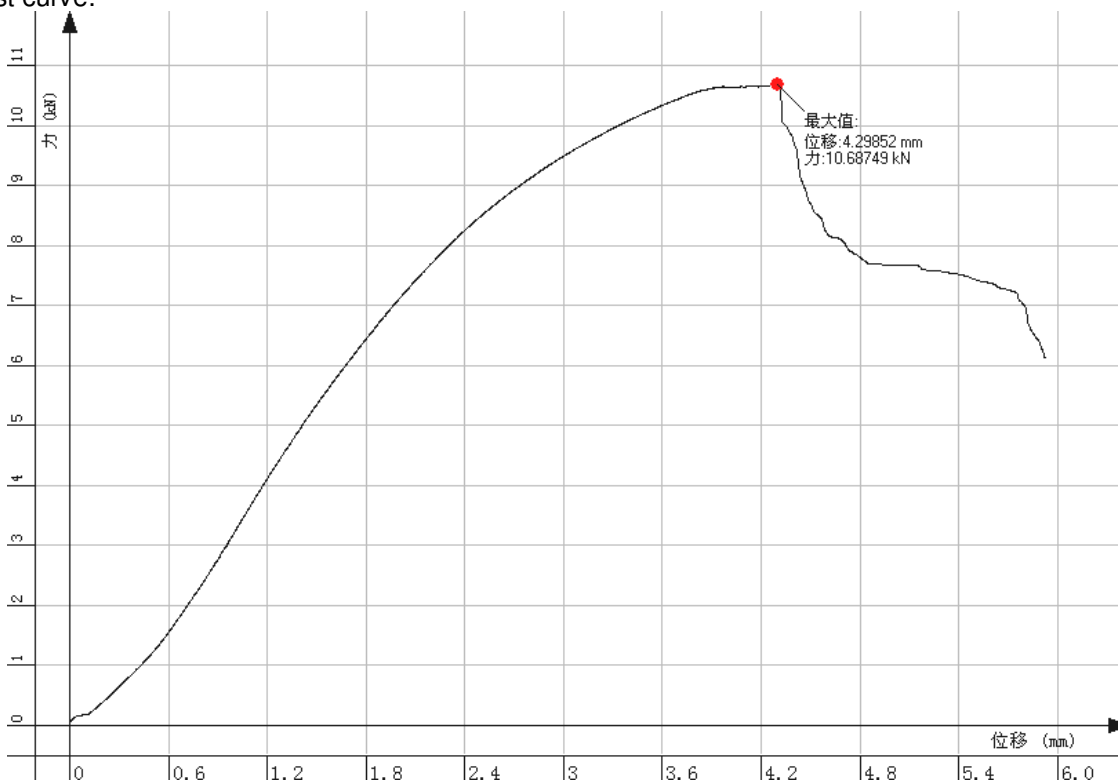
Test method: according to the client's requirements, fixed the sample on the test machine. Apply the pull force as a speed of 5mm/min till damage. Determine the maximum force.

Test item	Maximum force
Pull test	10.69kN

Force-displacement curve

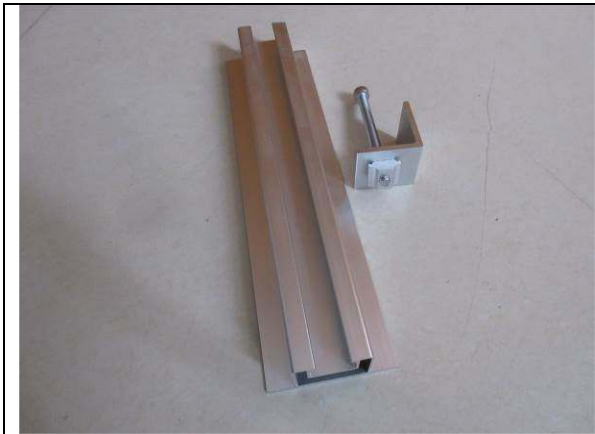
Photo 1: the sample before test

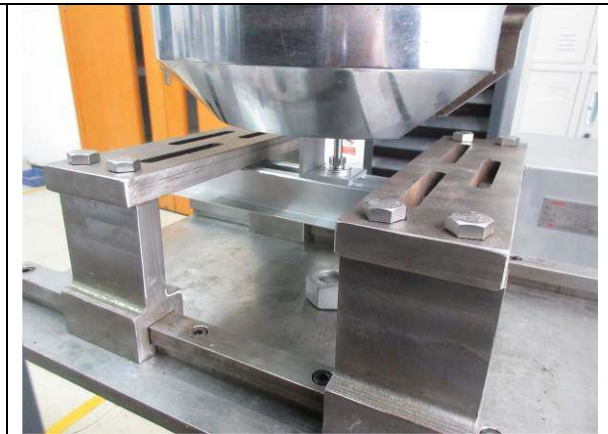
Photo 2: during the test

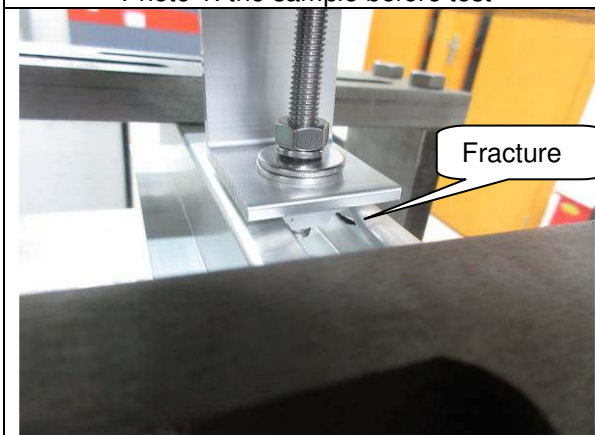
Photo 3: after the test

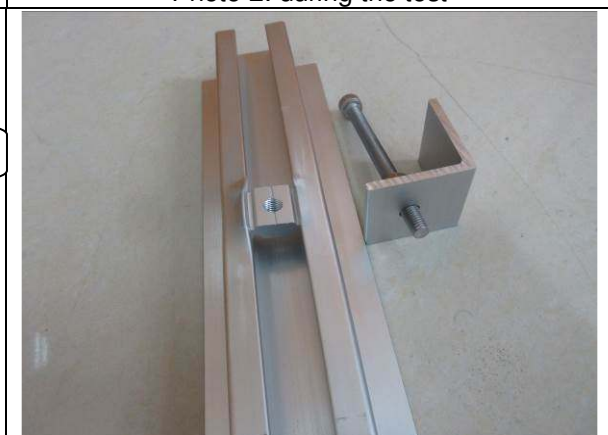
Photo 4: the sample after test
