## TEST REPORT

No. : XMIN1811008312ML

Sample Name : TILE HOOK #01

Material and Mark : SUS304

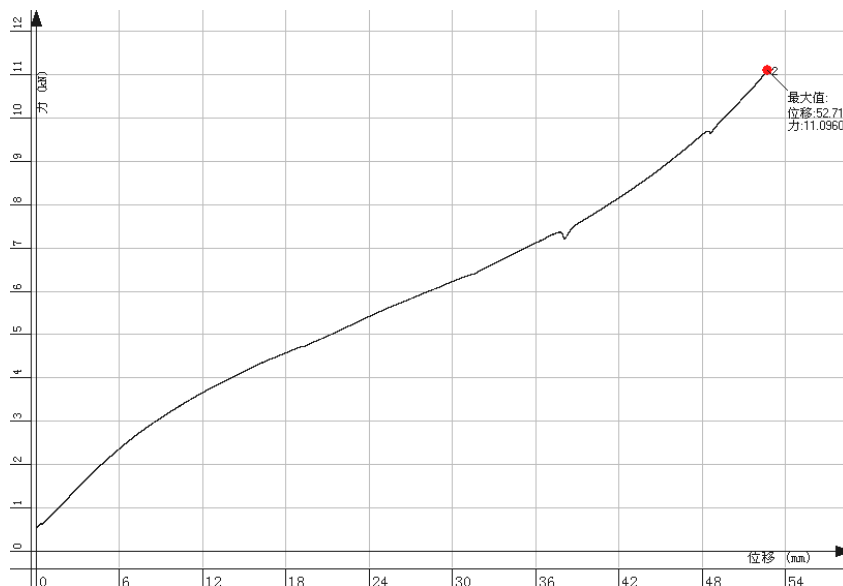
Force-displacement curve

Pull test:

Test method: according to the client's requirements, use self-tapping screws to lock the sample to the wood and fix the sample on the test machine. Apply the force with a rate of 5mm/min till destruction or obvious deformation. Determine the maximum force.

Test item	Maximum force in the test displacement interval (N)
Pull test	11096

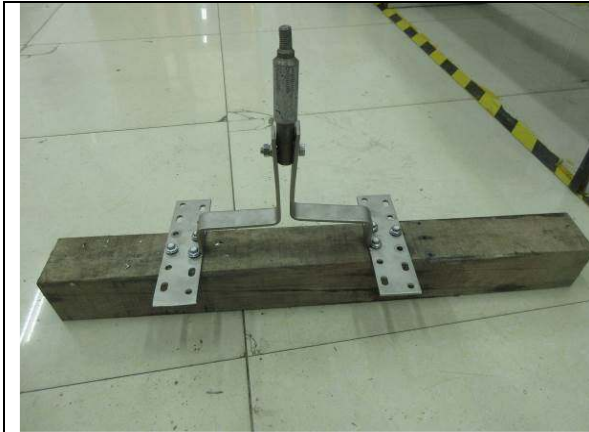
Photo 1: Sample

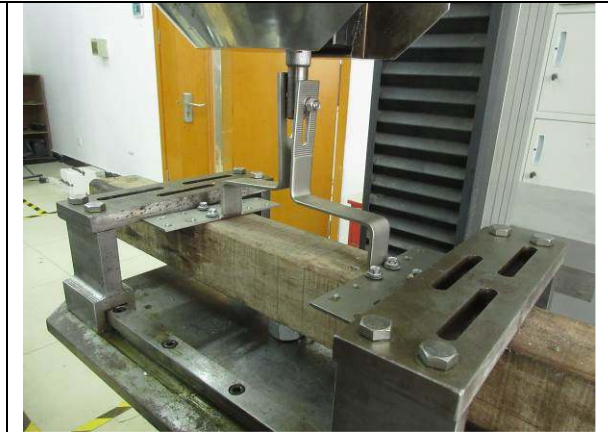
Photo 2: Before the test

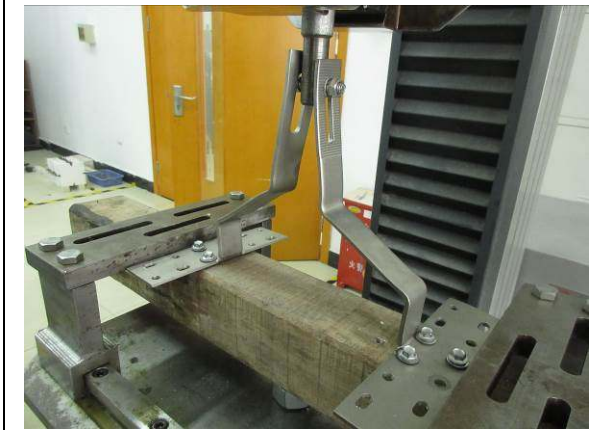
Photo 3: After the test

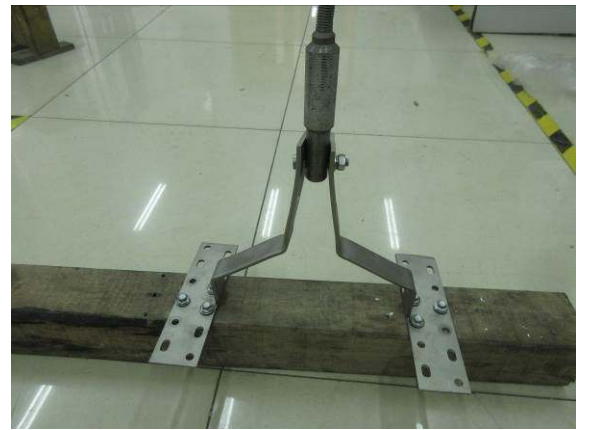
Photo 4: The sample after the test
